EFW Facility

Howmsgill Industrial Park, Consett

Ground Investigation Interpretive Report

Dysart Developments Ltd

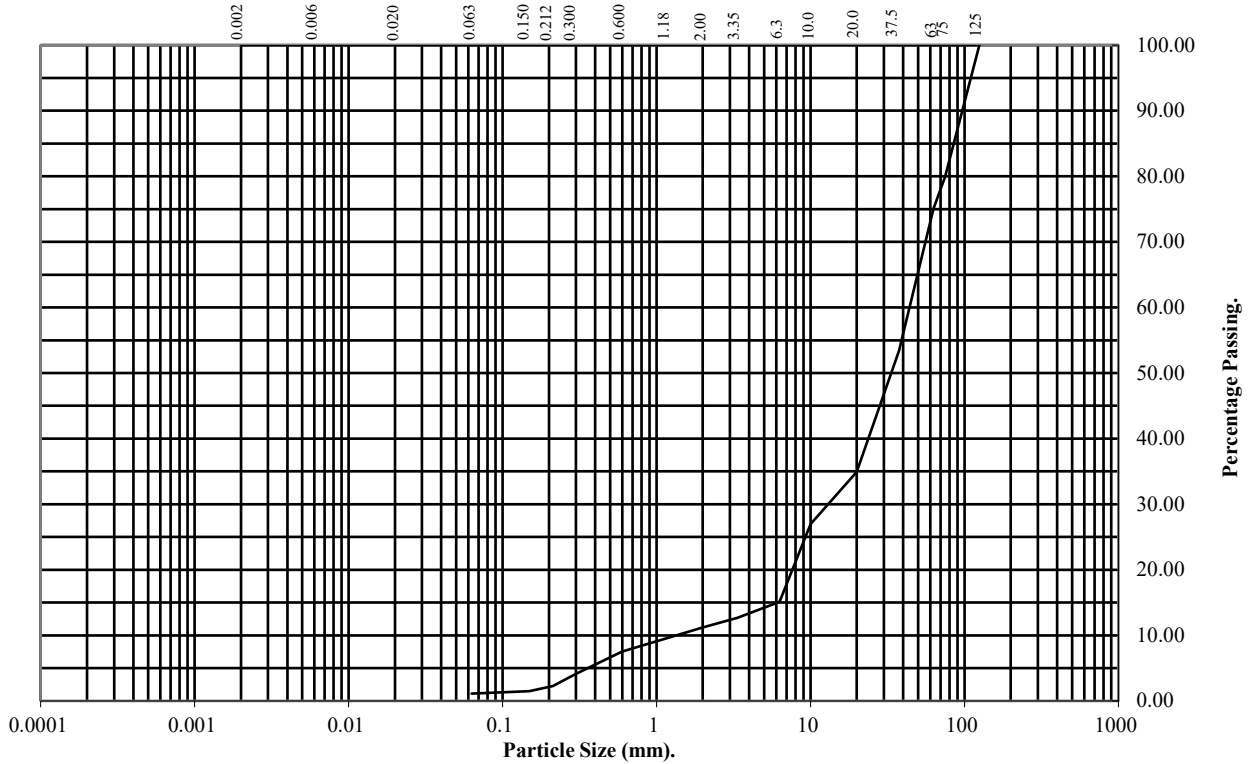
BS Test Sieve (mm)	Percentage Passing
125	100
75	80
63	75
37.5	53
20	35
10	27
6.3	15
3.35	13
2	11
1.18	10
0.6	8
0.3	4
0.212	2
0.15	1
0.063	1

Soil Fraction	Total Percentage
Cobbles	25
Gravel	64
Sand	10
Silt/Clay	1

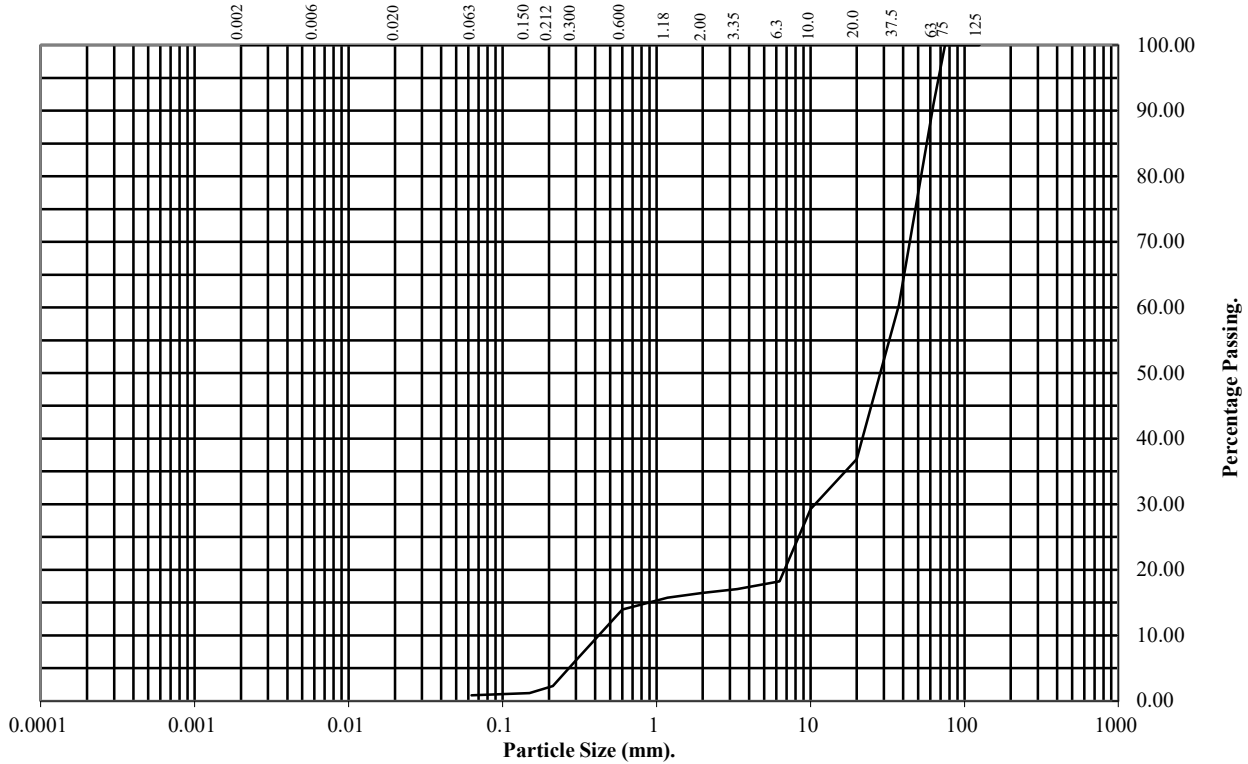
BS Test Sieve (mm)	Percentage Passing
125	100
75	100
63	91
37.5	60
20	37
10	29
6.3	18
3.35	17
2	16
1.18	16
0.6	14
0.3	6
0.212	2
0.15	1
0.063	1

Soil Fraction	Total Percentage
Cobbles	9
Gravel	75
Sand	15
Silt/Clay	1

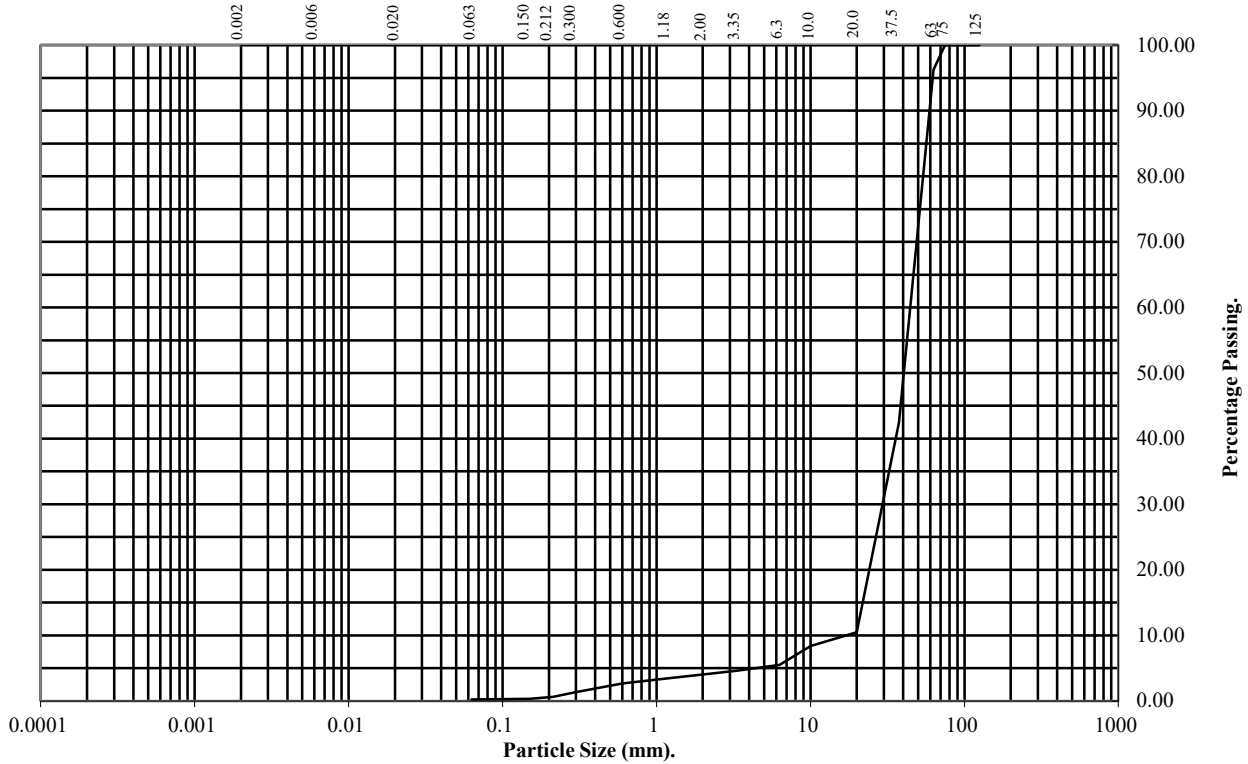
BS Test Sieve (mm)	Percentage Passing
125	100
75	100
63	96
37.5	42
20	10
10	8
6.3	5
3.35	5
2	4
1.18	3
0.6	3
0.3	1
0.212	1
0.15	0
0.063	0

Soil Fraction	Total Percentage
Cobbles	4
Gravel	92
Sand	4
Silt/Clay	0

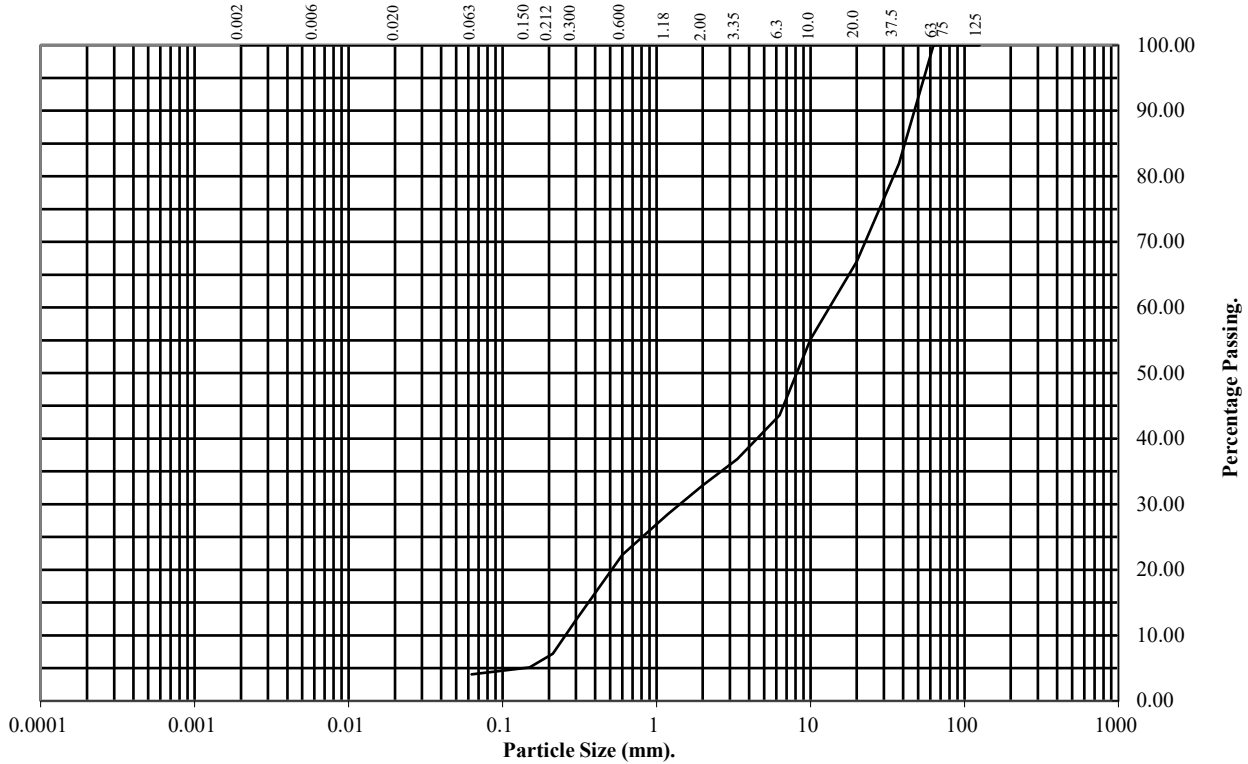
BS Test Sieve (mm)	Percentage Passing
125	100
75	100
63	100
37.5	82
20	67
10	55
6.3	44
3.35	37
2	33
1.18	28
0.6	22
0.3	12
0.212	7
0.15	5
0.063	4

Soil Fraction	Total Percentage
Cobbles	0
Gravel	67
Sand	29
Silt/Clay	4

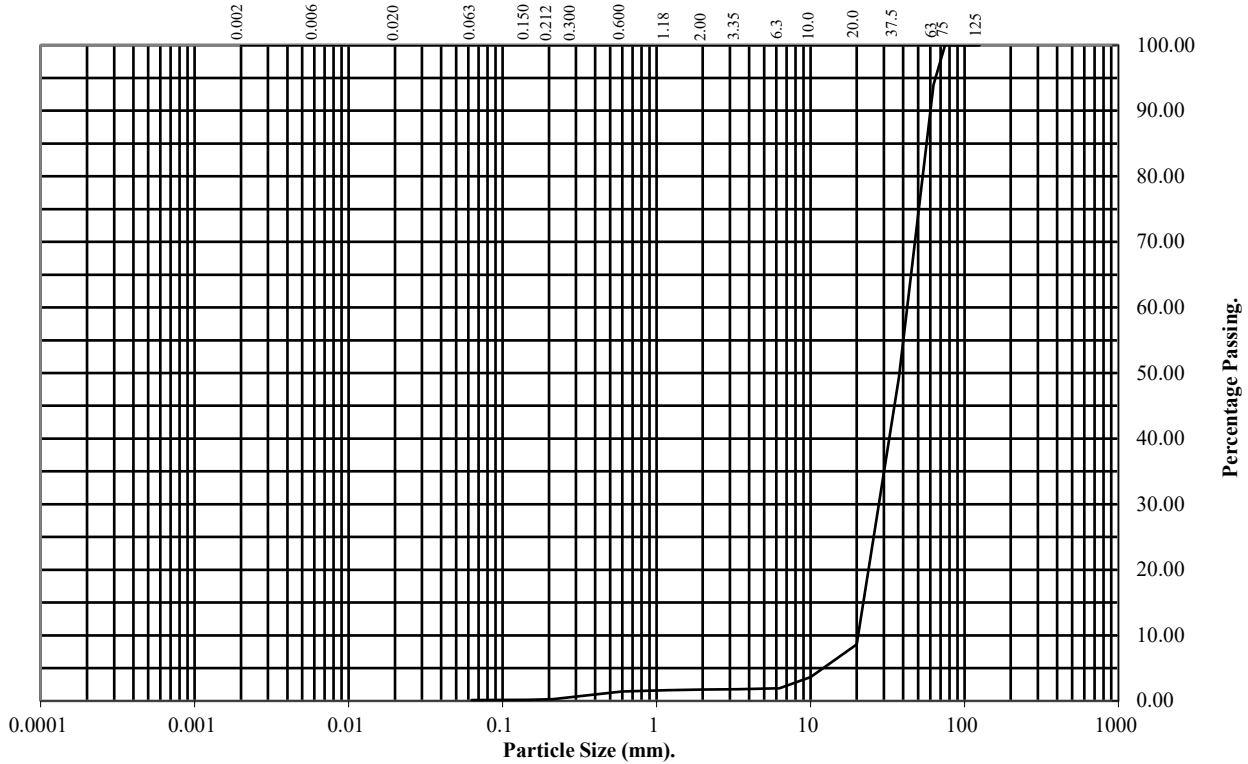
BS Test Sieve (mm)	Percentage Passing
125	100
75	100
63	94
37.5	49
20	9
10	4
6.3	2
3.35	2
2	2
1.18	2
0.6	1
0.3	1
0.212	0
0.15	0
0.063	0

Soil Fraction	Total Percentage
Cobbles	6
Gravel	92
Sand	2
Silt/Clay	0

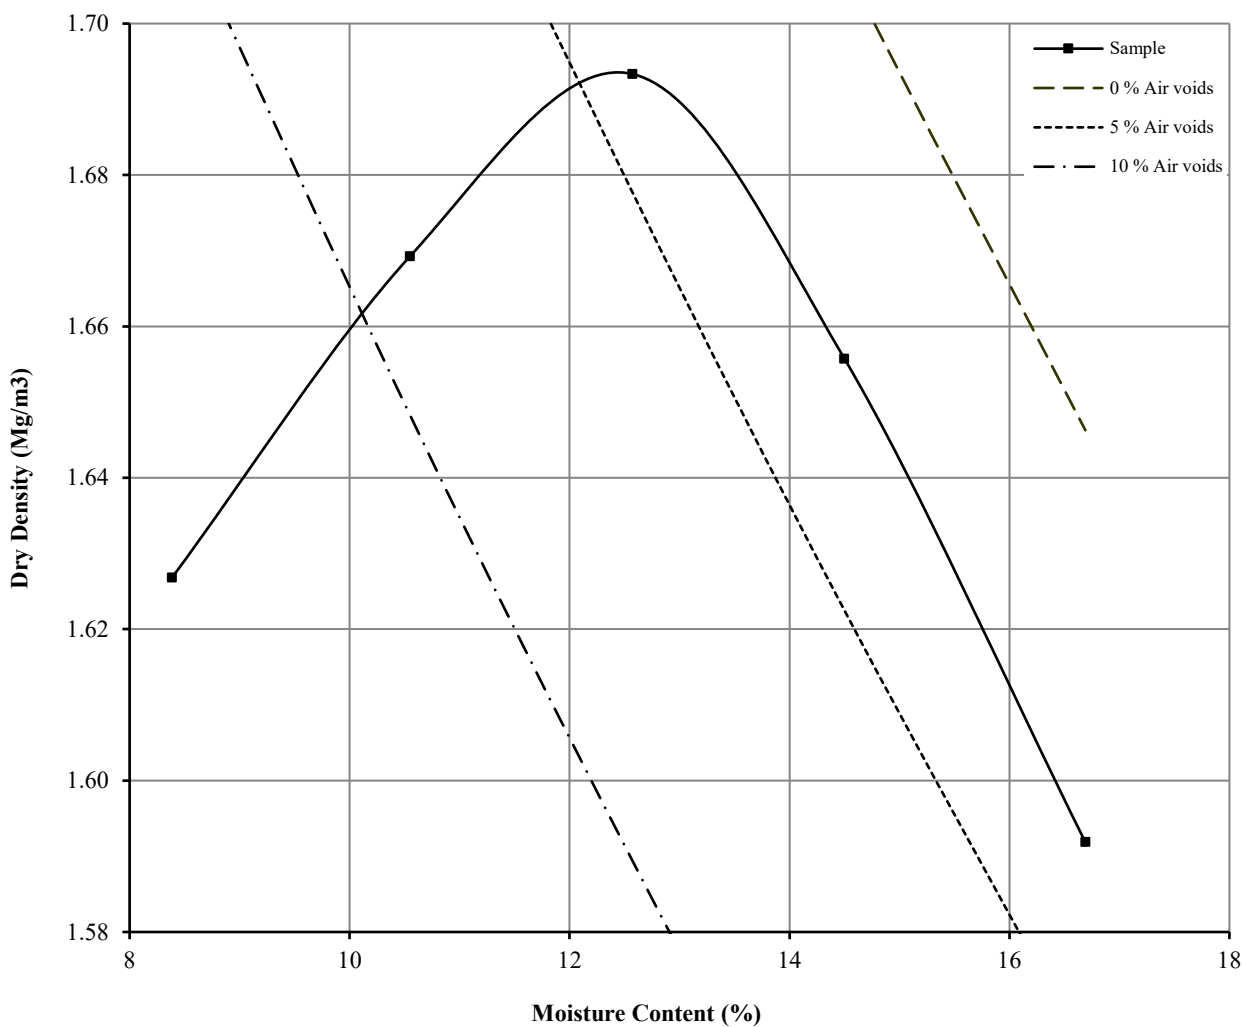
DRY DENSITY / MOISTURE CONTENT RELATIONSHIP

Hole Number: TP10 Top Depth (m) : 2.50
 Sample Number: Base Depth (m) :
 Sample Type: B

Initial Moisture Content:	11	Method of Compaction:	Vibro	Separate Samples
Particle Density (Mg/m ³):	2.27	Assumed	Material Retained on 37.5 mm Test Sieve (%):	18
Maximum Dry Density (Mg/m ³):	1.69		Material Retained on 20.0 mm Test Sieve (%):	15
Optimum Moisture Content (%):	13			
Remarks				
See summary of soil descriptions.

The laboratory earthworks testing undertaken on the gravel located at the site has shown that the compaction of the gravels is not affected by moisture (the laboratory could only provide the maximum and minimum dry density as the lack of fines content prevented a typical maximum dry density versus moisture content curve being produced).

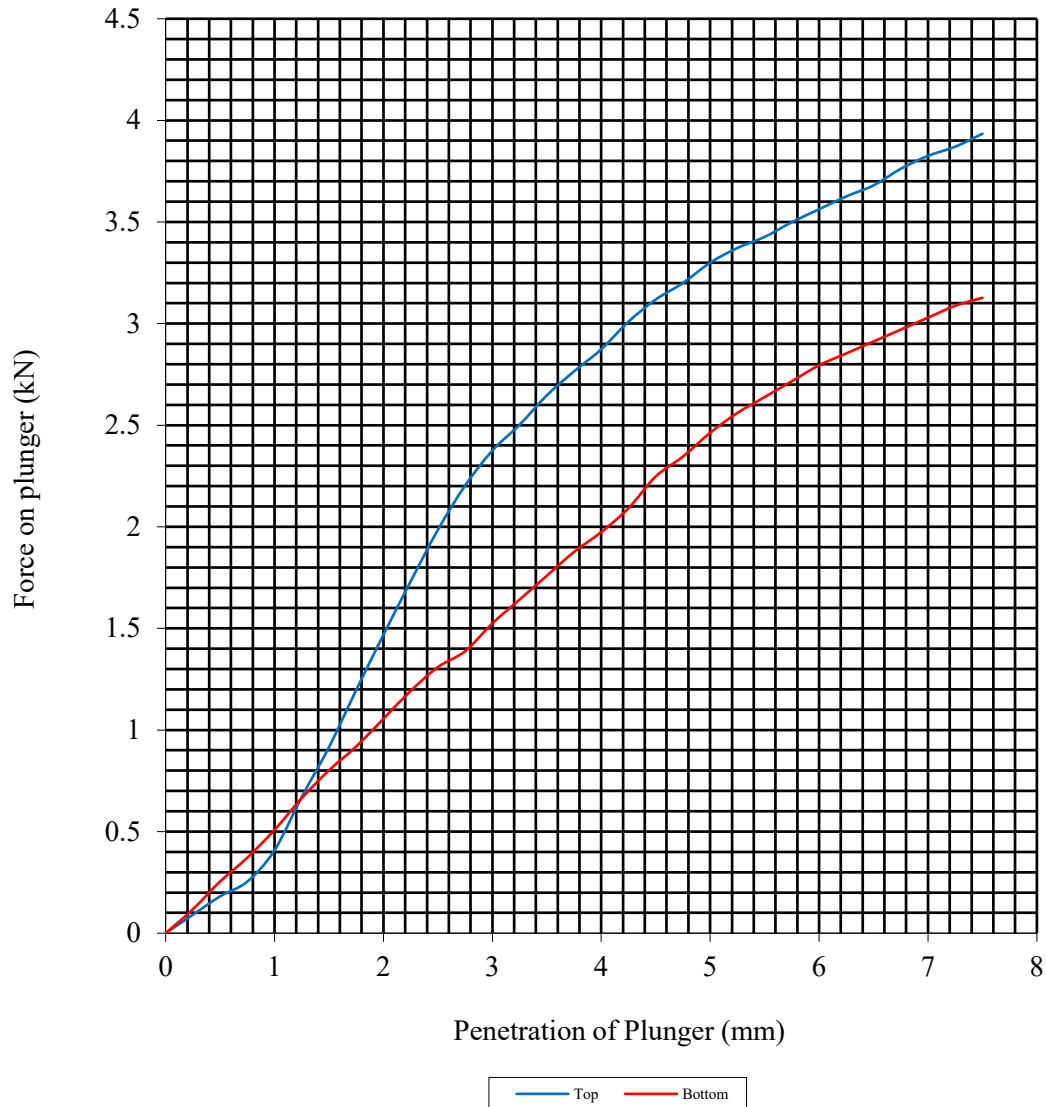
Initial Sample Conditions		Sample Preparation		Final Moisture Content %		C.B.R. Value %	
Moisture Content:	16	Surcharge Kg:	4.20	Sample Top	16	Sample Top	16.5
Bulk Density Mg/m ³ :	2.01	Soaking Time hrs	0	Sample Bottom	16	Sample Bottom	12.3
Dry Density Mg/m ³ :	1.74	Swelling mm:	0	Remarks : See Summary of Soil Descriptions.			
Percentage retained on 20mm BS test sieve:			0				
Compaction Conditions	2.5kg

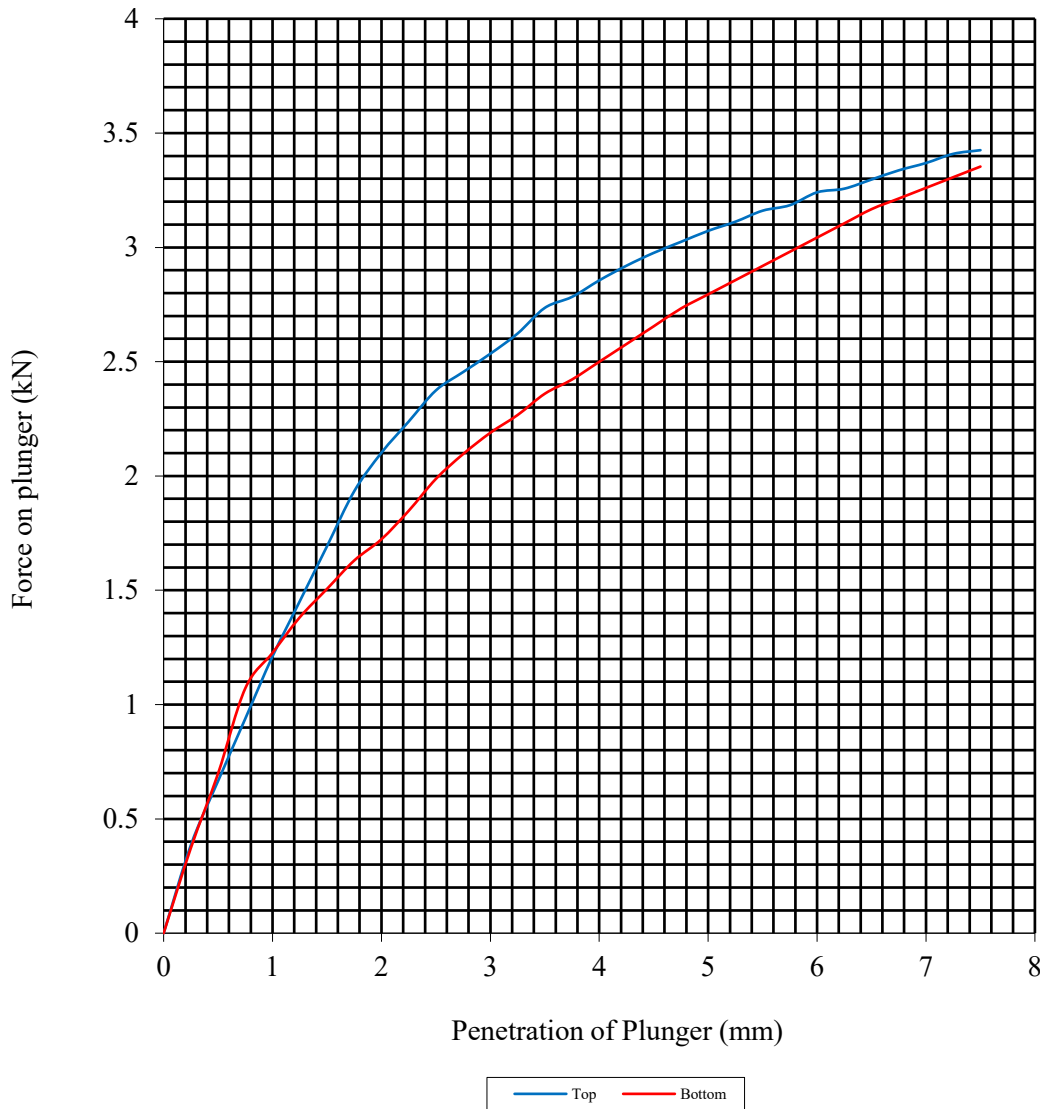
Initial Sample Conditions		Sample Preparation		Final Moisture Content %		C.B.R. Value %	
Moisture Content:	13	Surcharge Kg:	4.20	Sample Top	13	Sample Top	18.0
Bulk Density Mg/m ³ :	1.98	Soaking Time hrs	0	Sample Bottom	13	Sample Bottom	15.1
Dry Density Mg/m ³ :	1.75	Swelling mm:	0	Remarks : See Summary of Soil Descriptions.			
Percentage retained on 20mm BS test sieve:			0				
Compaction Conditions	2.5kg
